AFRL-ML-WP-TR-1998-4191

**CUT PROGRESSION DURING DYNAMOMETER
TESTING OF FOREIGN OBJECT DAMAGED TYPE
VII EXTRA HIGH PRESSURE AIRCRAFT TIRES
SAE PAPER 912155**

SEPTEMBER 1991

**MATERIALS AND MANUFACTURING DIRECTORATE
AIR FORCE RESEARCH LABORATORY
AIR FORCE MATERIEL COMMAND
WRIGHT-PATTERSON AIR FORCE BASE OH 45433-7750**

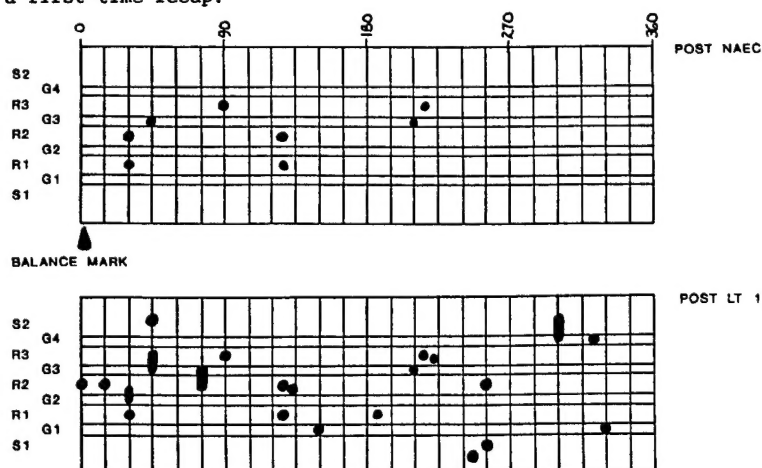
FIGURE 6: LEAST PRIMARY DAMAGE
3242-0717/X-2A RECAPPED TIRE

LEAST PRIMARY DAMAGE - Tire X-2A (recap) sustained the fewest primary cuts of all dynamometer tires run on the track at NAEC, and is presented in Figure 6. There were four primary cuts (with one

past the Cut Limit) and four primary blemishes. As it ran on the dynamometer, the primary damage increased, and secondary cuts and blemishes appeared. After lab segment LT 1, there were six primary cuts (two past the Cut Limit) and one primary blemish; and 12 secondary cuts (with two past the Cut Limit) and three secondary blemishes.

Only 1.9% of the impacts at NAEC resulted in primary cuts and another 1.9% resulted in primary blemishes. After LT 1, the number of all cuts equalled 8.7% of the number of impacts. The 450% increase in the number of cuts, and 275% increase in total damage were the top percentage increase of damage for all tires tested. The tire stripped 100% of the tread during TTO 2.

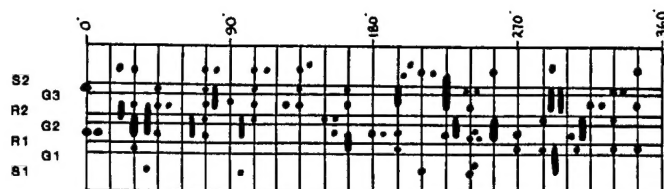
FIGURE 7: MOST PRIMARY DAMAGE
8202-0886/J-20 NEW TIRE

MOST PRIMARY DAMAGE - Tire J-20 (new) sustained the most primary cuts, and is presented in Figure 7. There were 81 primary cuts (ten past the Cut Limit) and six primary blemishes. After lab segment TTO 1, there were 86 primary cuts (11 past the Cut Limit) and no blemishes; and 27 secondary cuts (two past the Cut Limit) and three secondary blemishes.

Twenty three percent of the impacts resulted in primary cuts and 2% resulted in primary blemishes. After TTO 1, the number of all cuts equalled 33% of the impacts. This tire stripped 200 degrees of the inboard (R2) center rib during TTO 3.

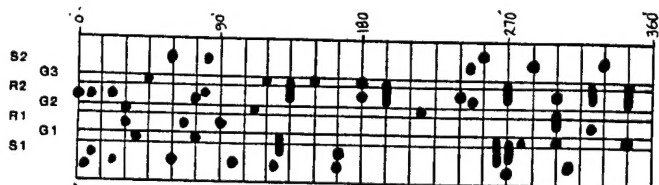
FIGURE 8: GREATEST SECONDARY DAMAGE
4044-0951/H-8 NEW TIRE

MOST SECONDARY DAMAGE - Tire H-8 (new) sustained more than the mean (40) number of cuts at NAEC, and is presented in Figure 8. There were 49 primary cuts (four past the Cut Limit) and one primary blemish. Growth of secondary damage after lab segment TTO 1 was dramatic. After TTO 1, there were 50 primary cuts (five past the Cut Limit) and no primary blemishes; and 43 secondary cuts (two past the Cut Limit) and one secondary blemish. The 43 secondary cuts after TTO 1 were the most noticed during this program.

Fourteen percent of the impacts resulted in primary cuts, and less than 1% resulted in primary blemishes. After TTO 1, the number of all cuts equalled 27% of the impacts. The tire completed 3 TTO and 3 LT segments without failure, and was removed from the test queue for the dynamometer.
